# Inspection Report

**Property Address:**  
480 Cocolalla Loop Rd.  
Cocolalla ID 83813

**Idaho Choice Inspections**

<b>Date:</b> 4/2/2018	<b>Time:</b> 09:00 AM	<b>Report ID:</b> 201-8052
<b>Property:</b> 480 Cocolalla Loop Rd. Cocolalla ID 83813	<b>Customer:</b> Lester Igo	<b>Real Estate Professional:</b> Brian Jacobs Evergreen Realty

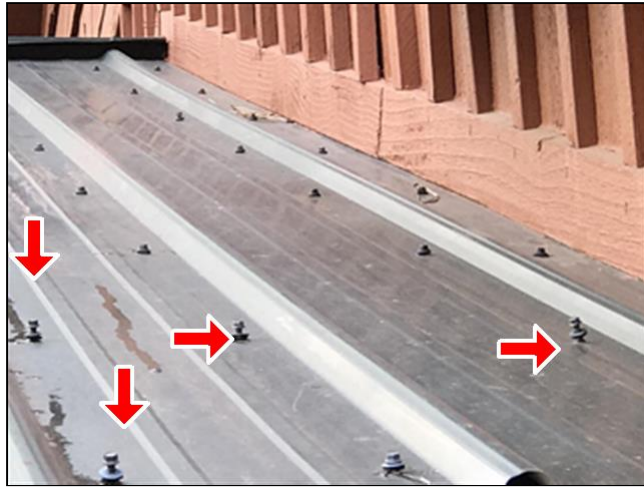
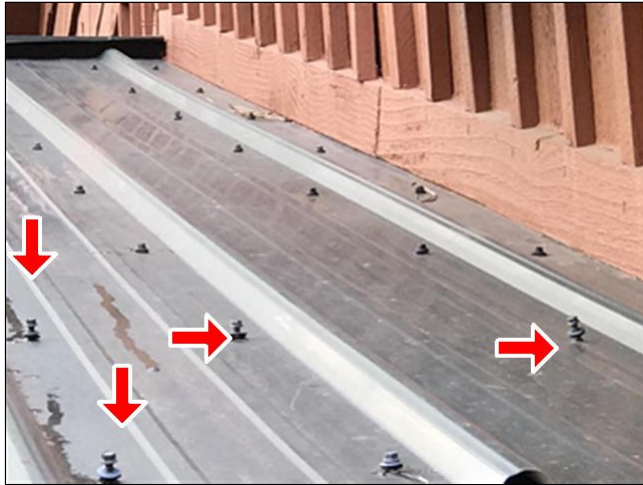
**1.0** The 1/4 inch roof screws are backing out or are missing at the roof and the roof is starting to show the early signs of water intrusion. This issue is common with metal roofs and is caused by climate changes and a lack of routine maintenance. I recommend tightening the current 1/4 inch screws or replacing them with larger 5/16 screws to prevent leaking.

1.0 Item 1(Picture) Loose roof screws

The 1/4 inch roof screws are backing out or are missing at the roof and the roof is starting to show the early signs of water intrusion. This issue is common with metal roofs and is caused by climate changes and a lack of routine maintenance. I recommend tightening the current 1/4 inch screws or replacing them with larger 5/16 screws to prevent leaking.

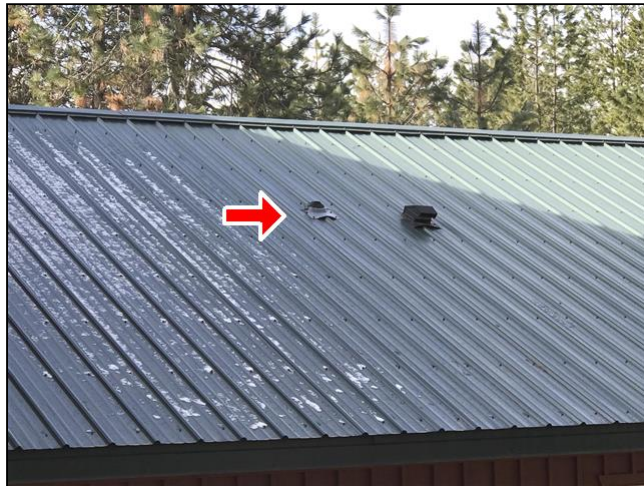
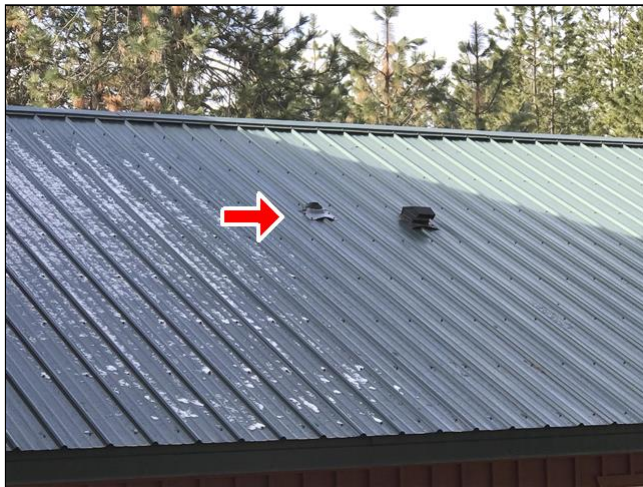
**1.2** At least one of the roof vent pipes is broken off at the roof. This issue is likely caused by the snow shedding from the roof and can be prevented from happening in the future by installing roof crickets

1.2 Item 1(Picture) Damaged/missing vent

At least one of the roof vent pipes is broken off at the roof. This issue is likely caused by the snow shedding from the roof and can be prevented from happening in the future by installing roof crickets

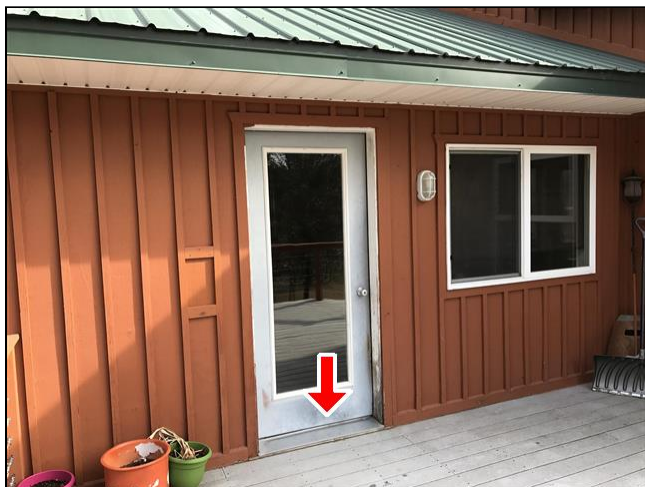
**1.4** There is splash damage at the front door (upper-level) consistent with the lack of rain gutter allowing the roof runoff water to come in contact with the door and door threshold. There are indications of water intrusion inside the home at the hardwood flooring. Some of the hardwood flooring in front of the door is damaged to a degree that replacing some if not all flooring will be required to correct this issue. I recommend installing snow breaks at the roof and rain gutters above the door to prevent this issue from continuing to get worse.

1.4 Item 1(Picture) Splash damage

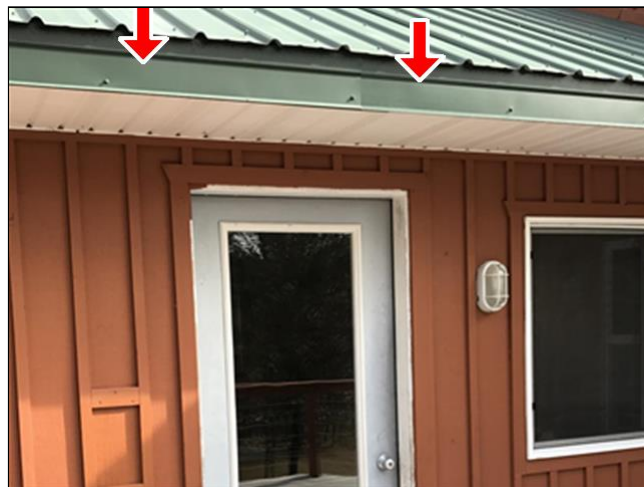
1.4 Item 2(Picture) No rain gutters

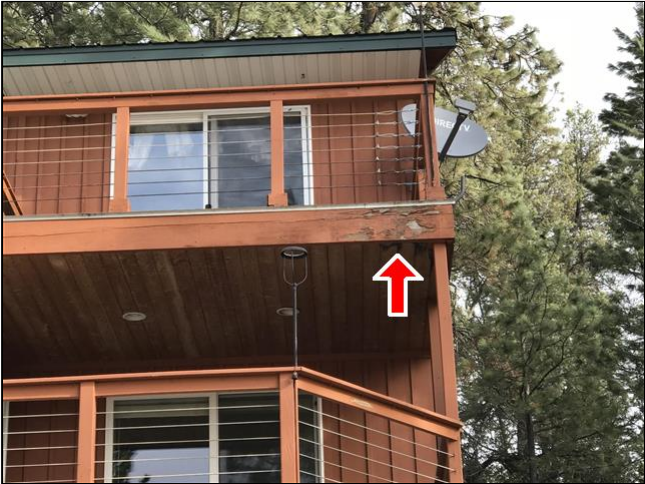
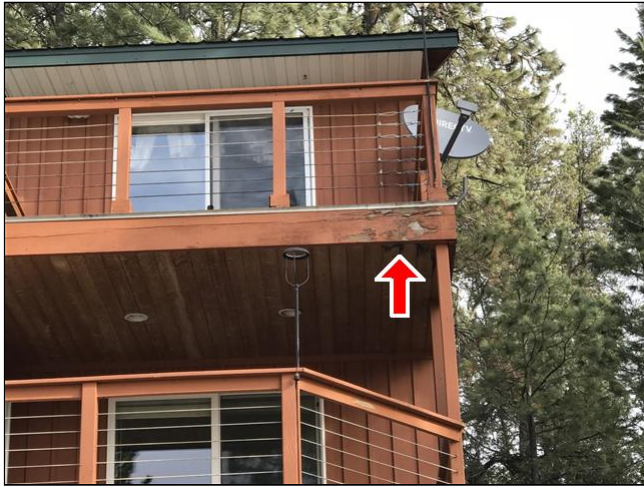
**2.0** There is peeling or blistering paint/ stain in various locations around the building. Peeling or blistering paint allows the structural components to be exposed to the elements which can cause water damage.(decay or dry rot) In homes constructed prior to 1978, peeling or blistering paint can be a potential health hazard due to the use of lead-based paints. This building was not constructed prior to 1978 and should not pose that particular hazard. Correcting this issue will require removing the loose or peeling paint and re-applying a fresh coat of paint or sealant to the exposed areas.

2.0 Item 1(Picture) Peeling paint

There is peeling or blistering paint/stain in various locations around the building. Peeling or blistering paint allows the structural components to be exposed to the elements which can cause water damage.(decay or dry rot) In homes constructed prior to 1978, peeling or blistering paint can be a potential health hazard due to the use of lead-based paints. This building was not constructed prior to 1978 and should not pose that particular hazard. Correcting this issue will require removing the loose or peeling paint and re-applying a fresh coat of paint or sealant to the exposed areas.

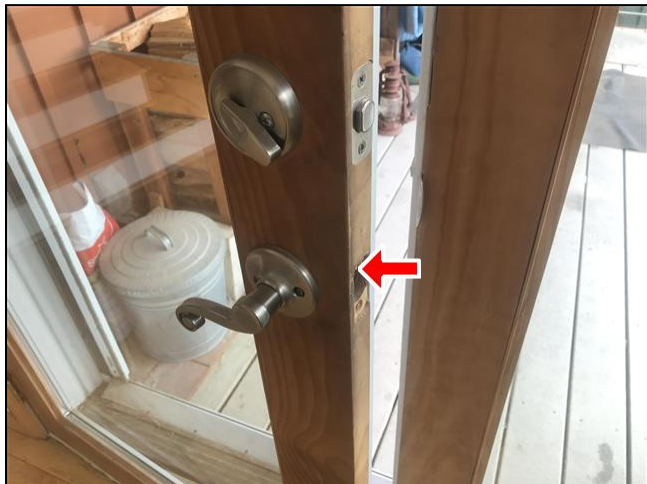
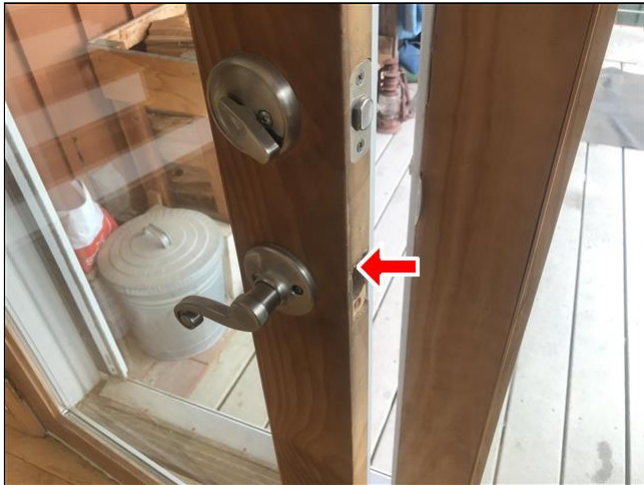
**2.1** The handle at the upstairs double doors is damaged or has missing parts. This issue prevents this door from securing without the use of the deadbolt. Replacement of the door hardware may be necessary.

2.1 Item 1(Picture) Missing parts

The handle at the upstairs double doors is damaged or has missing parts. This issue prevents this door from securing without the use of the deadbolt. Replacement of the door hardware may be necessary.

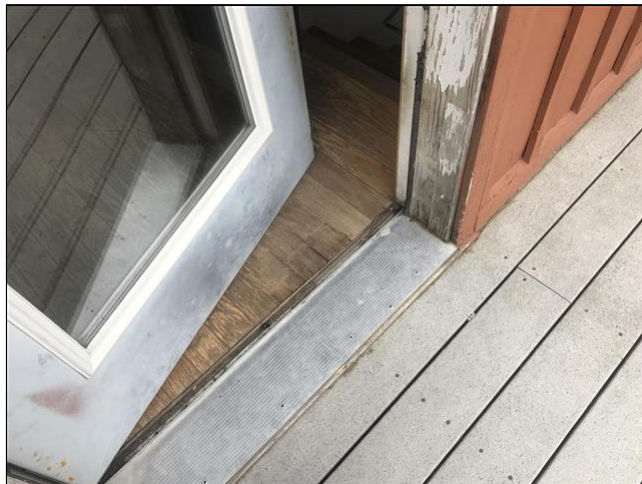
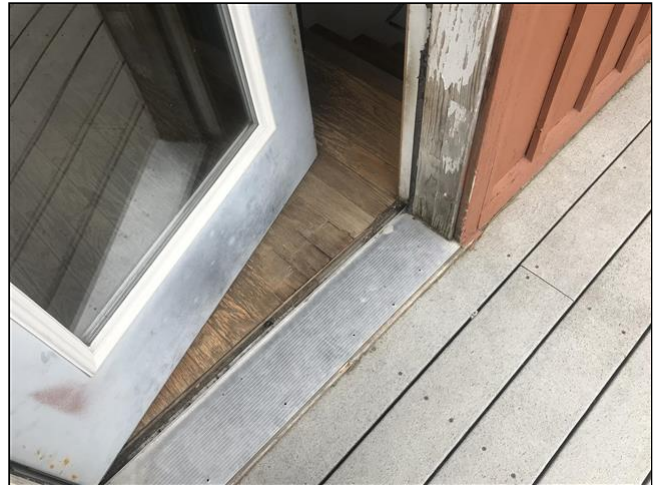
2.1 Item 2(Picture) Splash damage

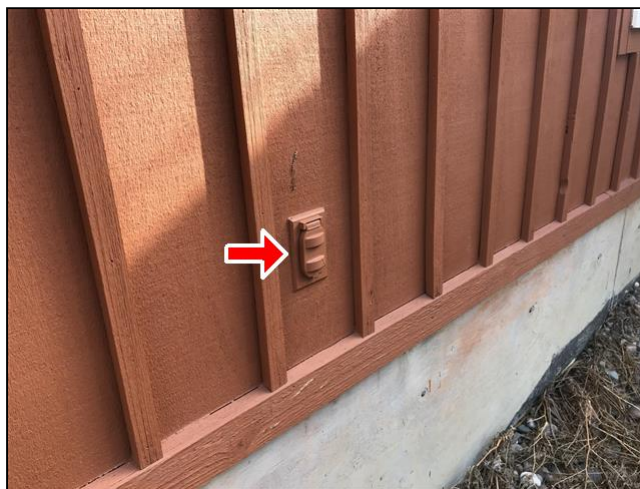
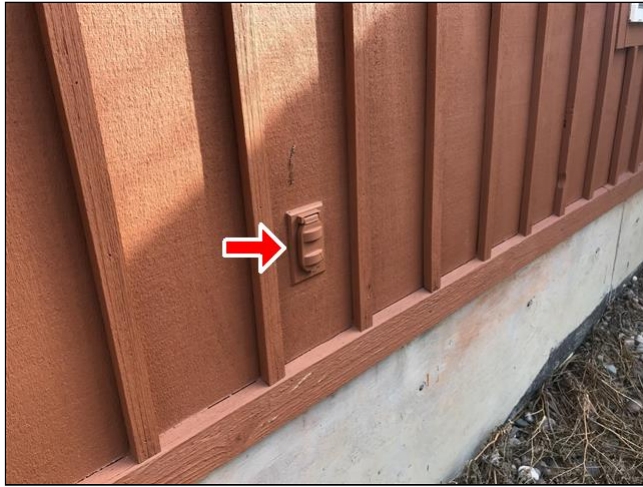
**2.7** There is no GFCI protection at the exterior. This means that either there was not a GFCI outlet at the exterior, there is not a GFCI breaker at the main electrical panel or if installed they did not trip/shut off the power as designed. A GFCI (Ground Fault Circuit Interrupter) outlet is needed at the exterior. Whenever electrical issues are discovered it is always recommended that a licensed electrical contractor conduct a more detailed and more invasive inspection of the home's electrical system.

2.7 Item 1(Picture) GFCI outlet needed

There is no GFCI protection at the exterior. This means that either there was not a GFCI outlet at the exterior, there is not a GFCI breaker at the main electrical panel or if installed they did not trip/shut off the power as designed. A GFCI (Ground Fault Circuit Interrupter) outlet is needed at the exterior. Whenever electrical issues are discovered it is always recommended that a licensed electrical contractor conduct a more detailed and more invasive inspection of the home's electrical system.

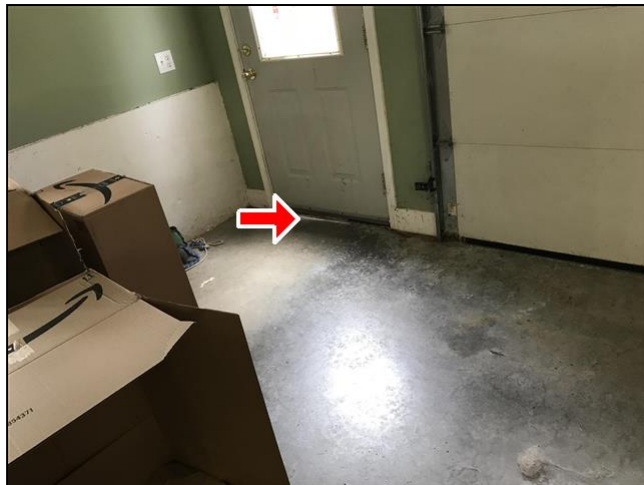
**3.3** The door sweep at the exterior garage man door is missing or damaged. Failure to have a door sweep at an exterior door will allow inclement weather to enter the home/garage.

3.3 Item 1(Picture) Visible daylight/missing door sweep

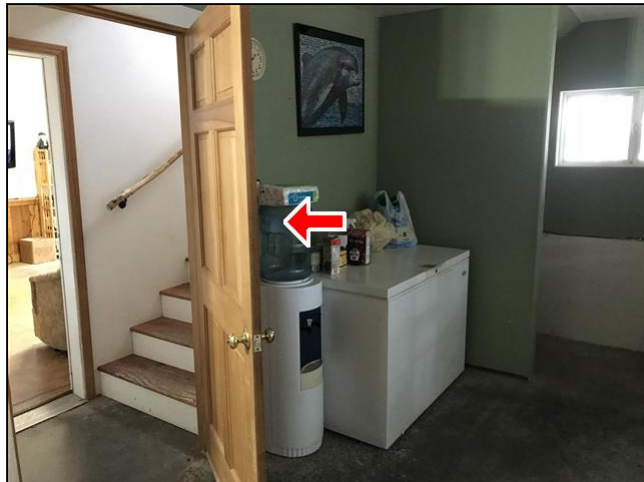
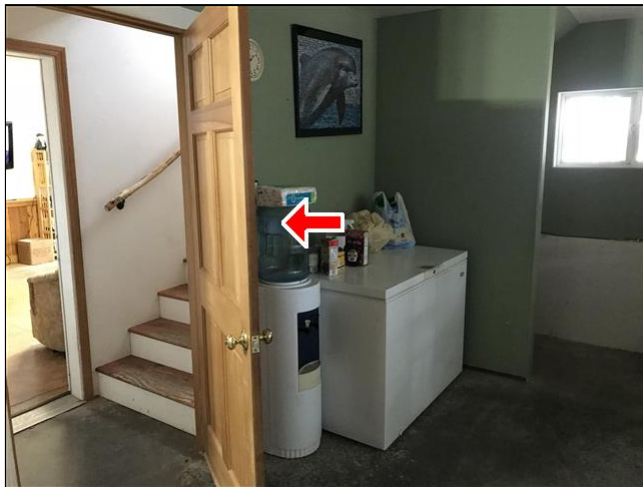
**3.4** The occupant door from inside the garage to inside the home is a fire rated door but the hinges are not working correctly or have been intentionally disabled. This means that should a fire occur in garage, the occupant door does not automatically close to afford protection until fireman arrive. This is a common issue I see with fire doors and requires only a minor adjustment or replacement of the hinges to correct this issue.

3.4 Item 1(Picture) Garage man door

The occupant door from inside the garage to inside the home is a fire rated door but the hinges are not working correctly or have been intentionally disabled. This means that should a fire occur in garage, the occupant door does not automatically close to afford protection until fireman arrive. This is a common issue I see with fire doors and requires only a minor adjustment or replacement of the hinges to correct this issue.

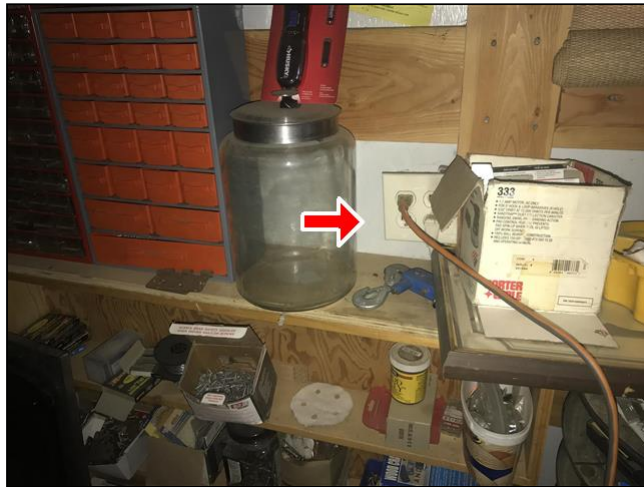
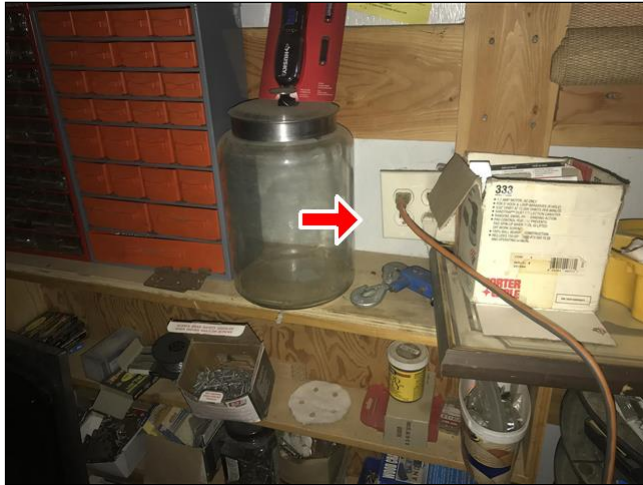
**3.6** There is not a GFCI (Ground Fault Circuit Interrupter) outlet installed at the shop to protect against accidental shock. A qualified person or a licensed electrical contractor should install a GFCI at that location. Whenever electrical issues are discovered it is always recommended that a licensed electrical contractor conduct a more detailed and more invasive inspection of the home's electrical system.

3.6 Item 1(Picture) GFCI outlet needed

There is not a GFCI (Ground Fault Circuit Interrupter) outlet installed at the shop to protect against accidental shock. A qualified person or a licensed electrical contractor should install a GFCI at that location. Whenever electrical issues are discovered it is always recommended that a licensed electrical contractor conduct a more detailed and more invasive inspection of the home's electrical system.

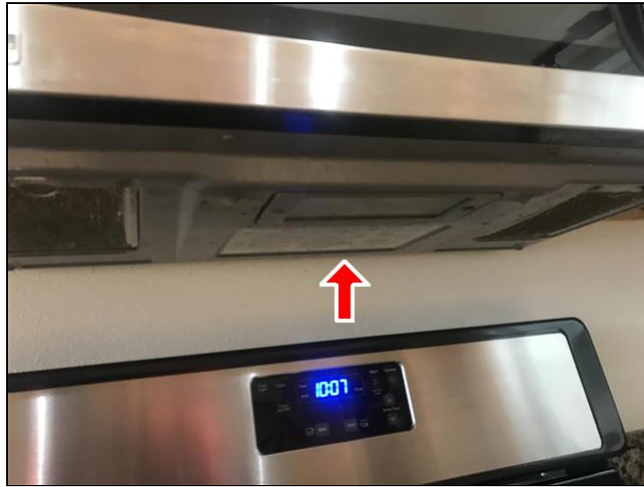
**4.11** The light at the range hood did not work at the time of inspection. There was power supplied to this fixture and therefore this issue is likely related to a burned out light bulb.

4.11 Item 1(Picture) Lightbulb not working

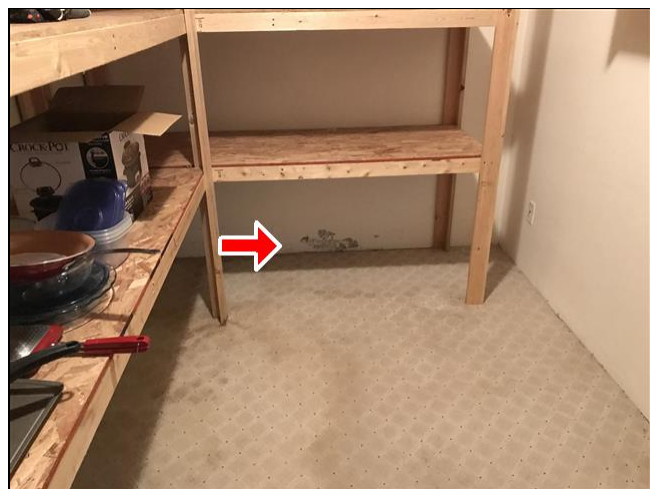
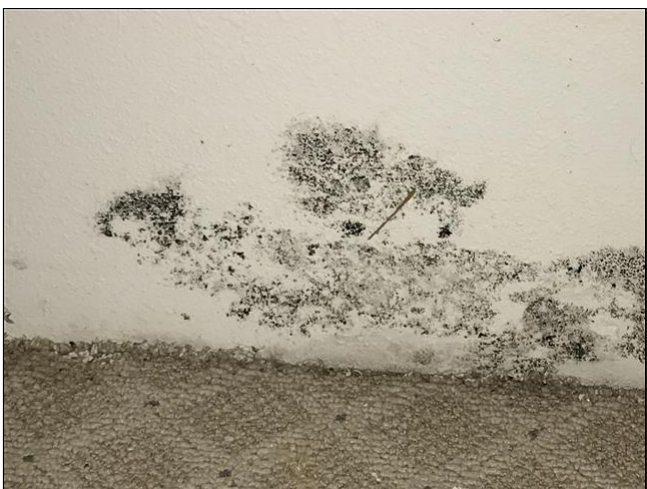
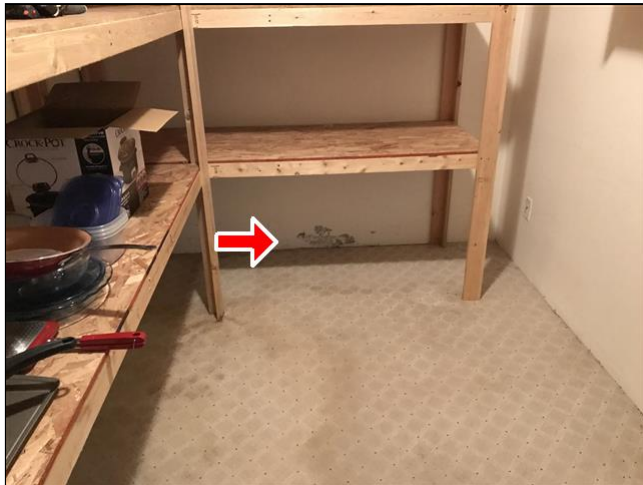
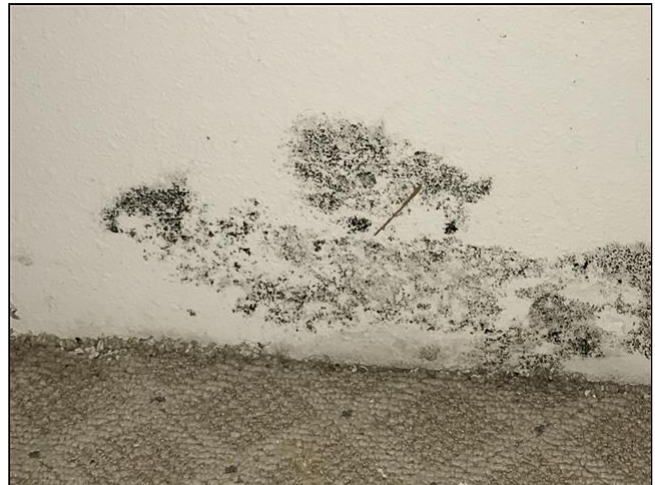
5.1 (1) There is a mold or fungus like substance present on the storage room wall at the basement living quarters. A sample of this substance was taken as well as airborne samples of the home to determine if there are any potential health hazards associated with this substance. Results pending ( estimated return date April 6)

5.1 Item 1(Picture) Mold like substance

5.1 Item 2(Picture) Mold like substance

(1) There is a mold or fungus like substance present on the storage room wall at the basement living quarters. A sample of this substance was taken as well as airborne samples of the home to determine if there are any potential health hazards associated with this substance. Results pending ( estimated return date April 6)

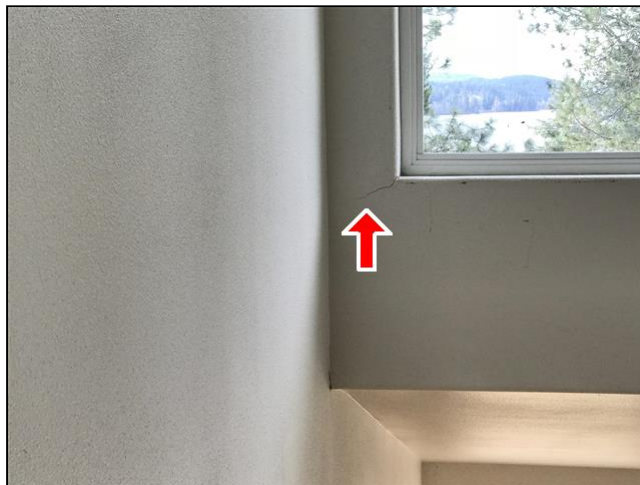
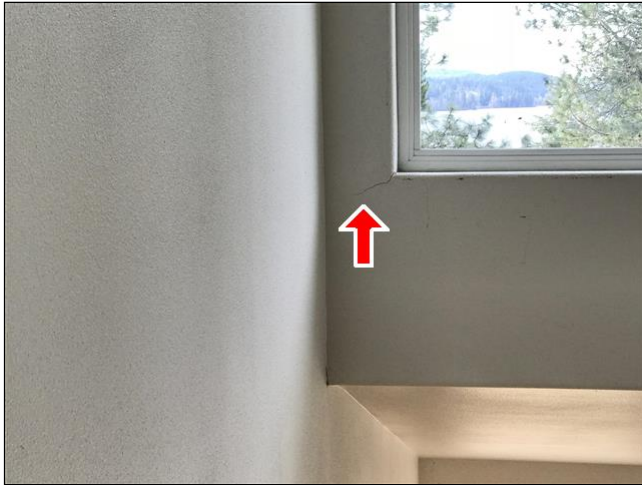
**5.1** (2) There are settling cracks at various locations throughout the house. Settling cracks generally occur within the first five years of construction or in regions where climate conditions cause frost heaves in the soil. Settling cracks are neither structural nor uncommon to this region and are by nature a cosmetic issue only.

5.1 Item 3(Picture) Settling crack

(2) There are settling cracks at various locations throughout the house. Settling cracks generally occur within the first five years of construction or in regions where climate conditions cause frost heaves in the soil. Settling cracks are neither structural nor uncommon to this region and are by nature a cosmetic issue only.

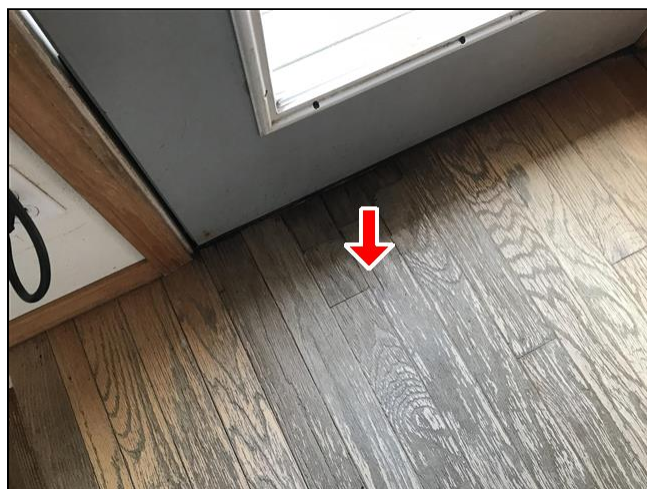
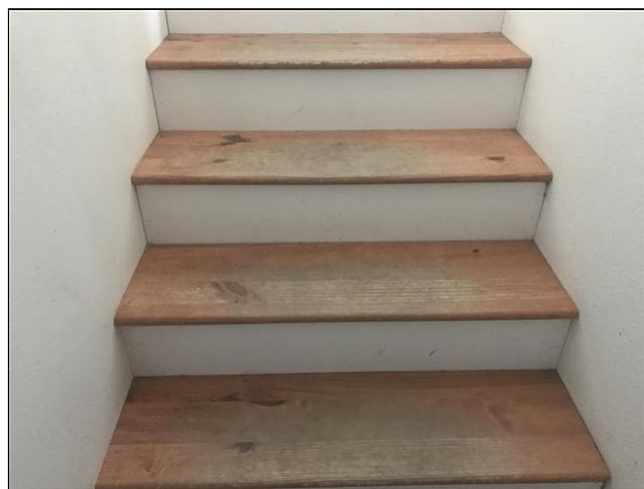
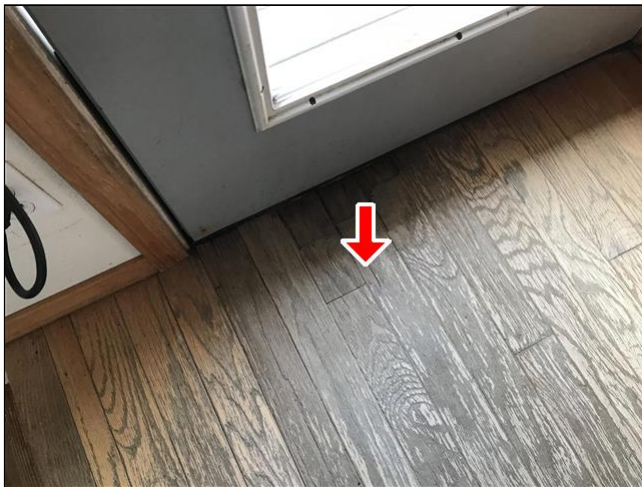
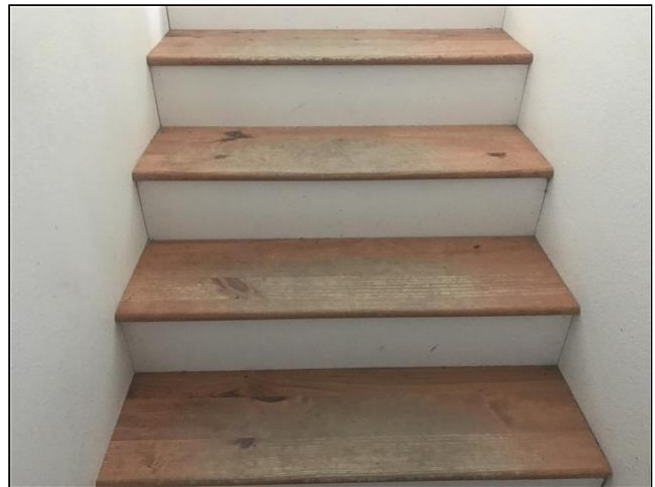
**5.2** The hardwood flooring throughout the house are water damaged and worn. Correcting this issue will require this flooring to be resurfaced, if not replaced in some areas due to damage.

5.2 Item 1(Picture) Damaged hardwood floor

5.2 Item 2(Picture) Damaged hardwood flooring

The hardwood flooring throughout the house are water damaged and worn. Correcting this issue will require this flooring to be resurfaced, if not replaced in some areas due to damage.

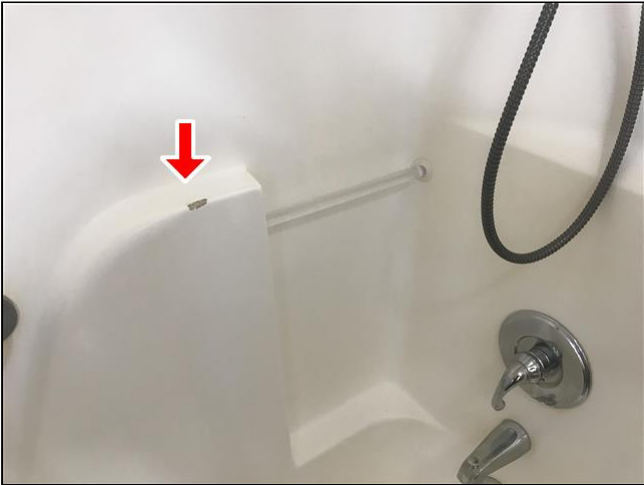
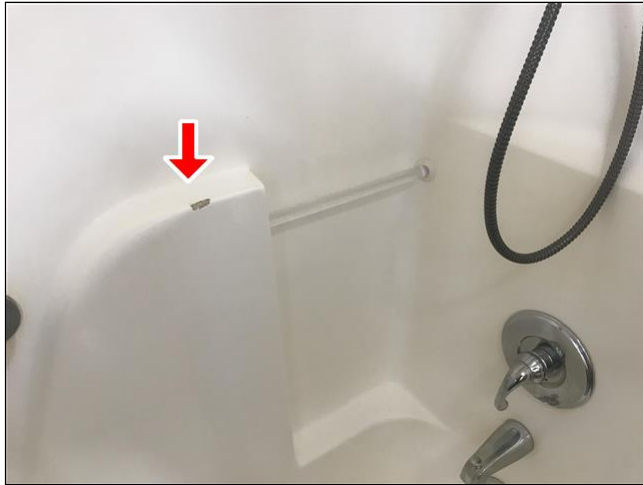
6.4 The shower stall has damage to the shower basin. This issue can be repaired utilizing a shower basin epoxy.

6.4 Item 1(Picture) Damaged shower basin

The shower stall has damage to the shower basin. This issue can be repaired utilizing a shower basin epoxy.

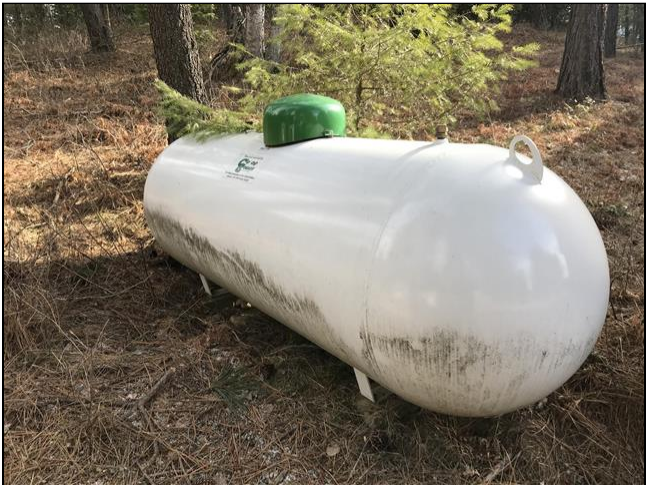
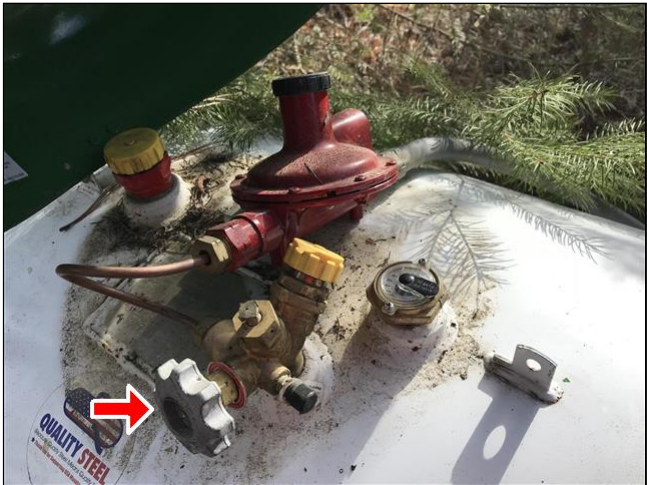
8.4 The main fuel shut off is at propane tank outside.

8.4 Item 1(Picture) Fuel tank

8.4 Item 2(Picture) Main fuel shutoff

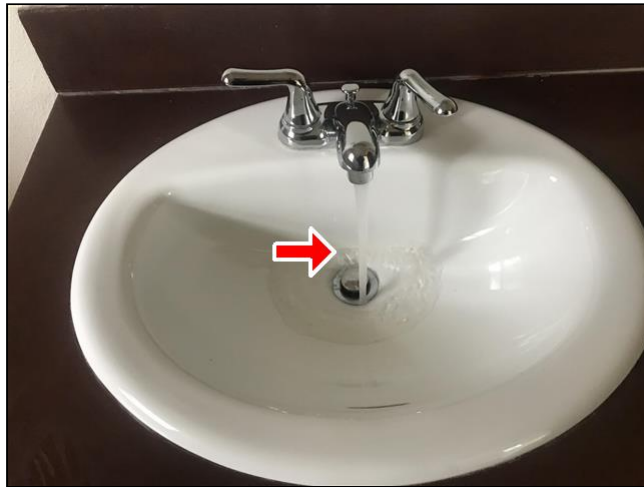
**8.6** The water pressure throughout the house was good when all faucets were simultaneously activated.

8.6 Item 1(Picture) Water pressure

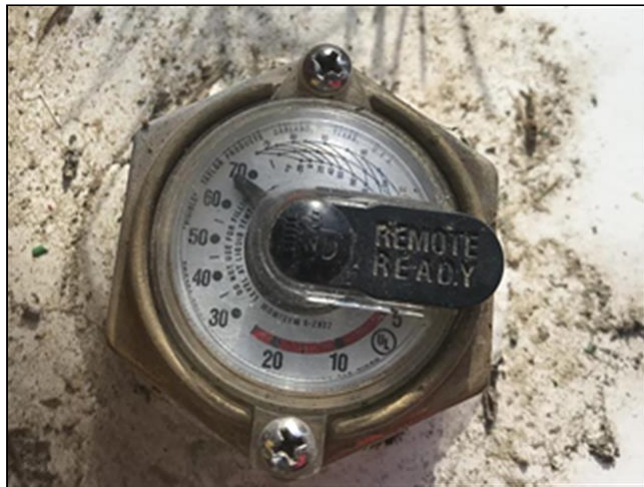
**8.7** The fuel level at the time of inspection was approximately 70%.

8.7 Item 1(Picture) Current fuel level

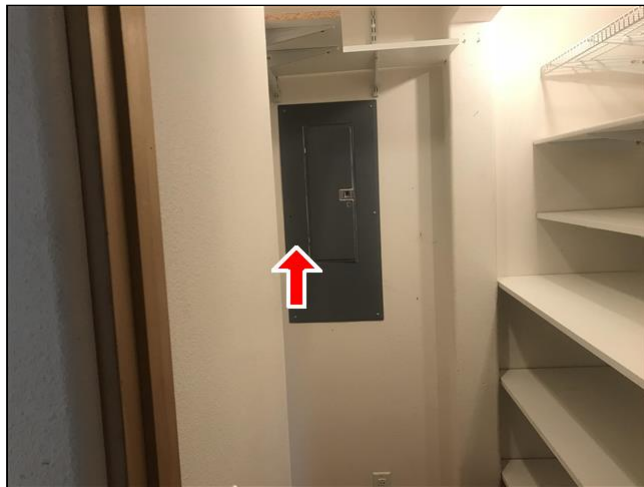
**9.6** The main panel box is located at the main floor storage room.

9.6 Item 1(Picture) Main panel

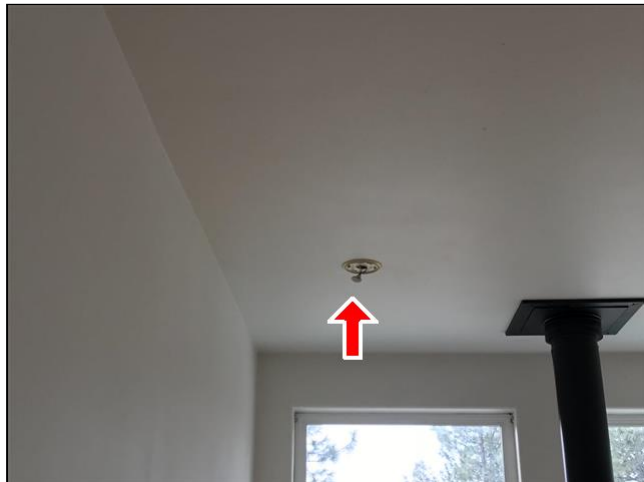
**9.7** Some if not all of the smoke alarms throughout the house have missing or have dead batteries. I encourage replacing the batteries every six months as part of routine home owner maintenance.

9.7 Item 1(Picture) Missing smoke alarm
